Transportation Safety Board
of Canada

AVIATION INVESTIGATION REPORT
A13O0045

RUNWAY INCURSION AND RISK OF COLLISION

SUNWING AIRLINES VEHICLE AND
AIR CANADA EMB190 C-FLWH
TORONTO LESTER B. PEARSON INTERNATIONAL AIRPORT
11 MARCH 2013

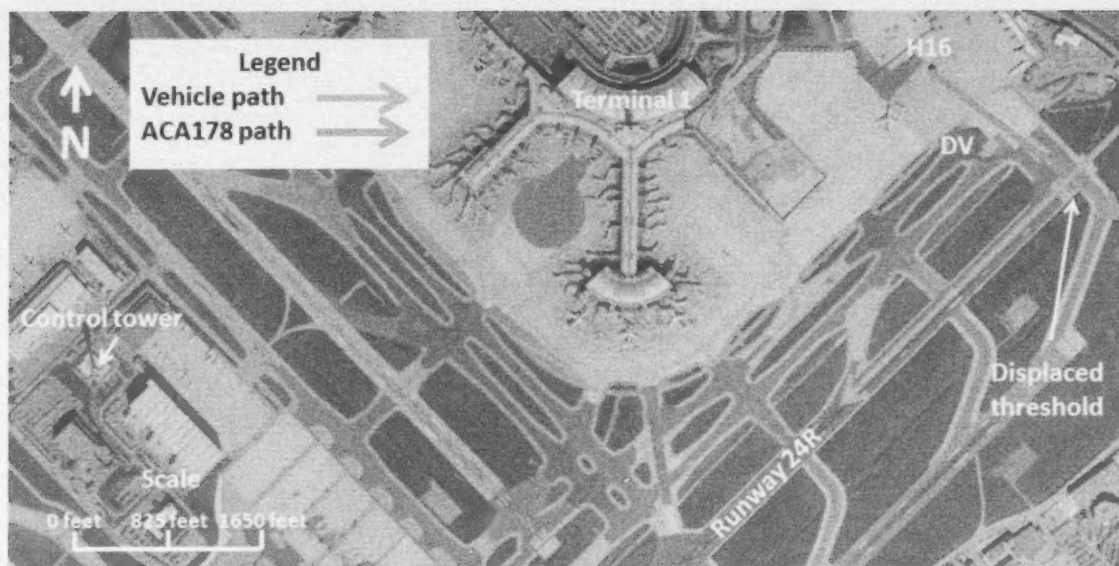
Figure 1. Occurrence map

Sunwing Airlines Inc. (Sunwing) is a charter operator based at Toronto-Lester B. Pearson International Airport (CYYZ), Ontario. A large portion of the company's fleet undergoes maintenance and grooming during the evenings. Generally, these routine tasks are performed while the aircraft are parked at gates set aside for this type of operation on the east side of Terminal 1 (Figure 1).

While the technician was inside the aircraft, the unattended vehicle, at idle and in drive gear, had begun to roll. The vehicle grazed the outer cowling of C-FTLK's left engine and continued under the wing in the direction of the threshold of Runway 24R, the active arrival runway. As the vehicle proceeded across the apron and maneuvering area, the speed varied between 1 and 5 mph, likely due to the gradual slopes in the pavement. The vehicle crossed Runway 24R perpendicularly, almost directly over the displaced threshold, continued straight across taxiway D7 and into the grass where it struck a taxiway reflector sign and became stuck. The vehicle was located 14 minutes later, with the engine running, headlights, taillights, and beacon on, and the automatic transmission in drive.

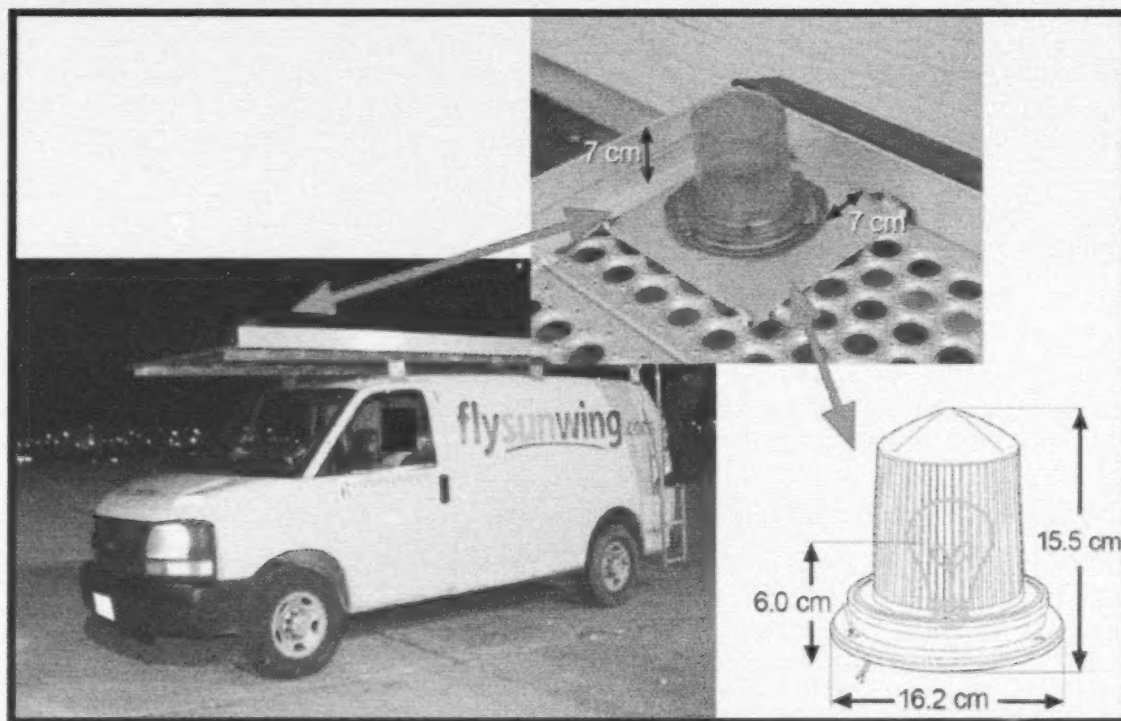
Figure 2. Grote beacon light installation on the maintenance van

Affixed to the roof of the van was a large aluminum work platform with a ladder running down the left side. Attached to the front left corner of the platform was an orange beacon light. The beacon was approximately 15.5 cm tall and was mounted 7 cm from a 7 cm tall skirt, which surrounds the platform. From a position 3 degrees above horizontal, similar to an approaching

aircraft's perspective, the bottom 6.6 cm of the beacon would not be visible. The filament of the bulb was located 6 cm from the base (Figure 2).

The beacon is designed to use a #1295 bulb, which is 37.5 W, to provide the 40 candelas specified by Transport Canada.⁶ After the incident, it was determined that the bulb inside the occurrence beacon was only 7 W. It could not be determined why or when the incorrect bulb was installed.

- **Airside vehicle beacon safety blitz:** GTAA aviation safety officers undertook spot checks and airside traffic stops of any vehicle that appeared to have a weak or inoperative roof beacon, and directed drivers to have vehicle beacons repaired or replaced.

Sunwing Airlines reported to Transport Canada Civil Aviation that it had inspected all of its airside vehicles' rotating beacon bulbs, and that bulbs found not to meet the specifications of TP312 were replaced to meet it.
